Distributed fiber optics sensing and coda wave interferometry techniques for damage monitoring in concrete structures

Article

Distributed Fiber Optics Sensing and Coda Wave Interferometry Techniques for Damage Monitoring in Concrete Structures

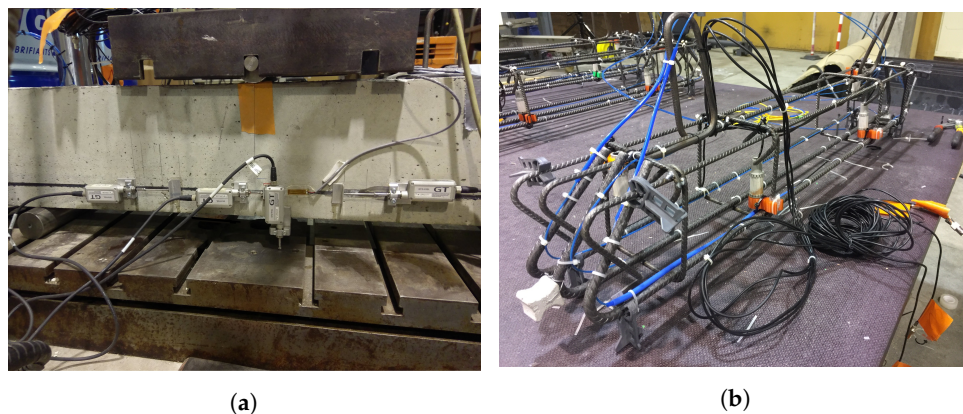
A $20 \times 20 \times 100$ cm reinforced concrete beam was tested under continuous three-point loading with a loading speed of 1 kN/min (Figure 3a). As shown in Figure 4a, the beam was reinforced with three $\phi 10$ longitudinal reinforcement bars (rebars) in the tension area and three $\phi 6$ rebars in the compression area, attached together by four $\phi 6$ stirrups. The beam was instrumented with SG (green color), LVDT (grey color), Ultra Sonic US (red color) and DFO (blue color) sensors. Before casting of concrete, four US sensors were attached to the stirrups while one optical cable was fixed over the length of four rebars (Figure 3b). After casting, the same optical cable was bonded to the surface of the beam by making a groove in the concrete at the same level of rebars and gluing the optical cable using a two components epoxy adhesive.

Figure 3. (a) front view of the loading arrangement and the beam instrumented with sensors before testing; (b) Ultra Sonics (US) and Distributed Fiber optics (DFO) sensors attached to the rebars before casting of concrete.

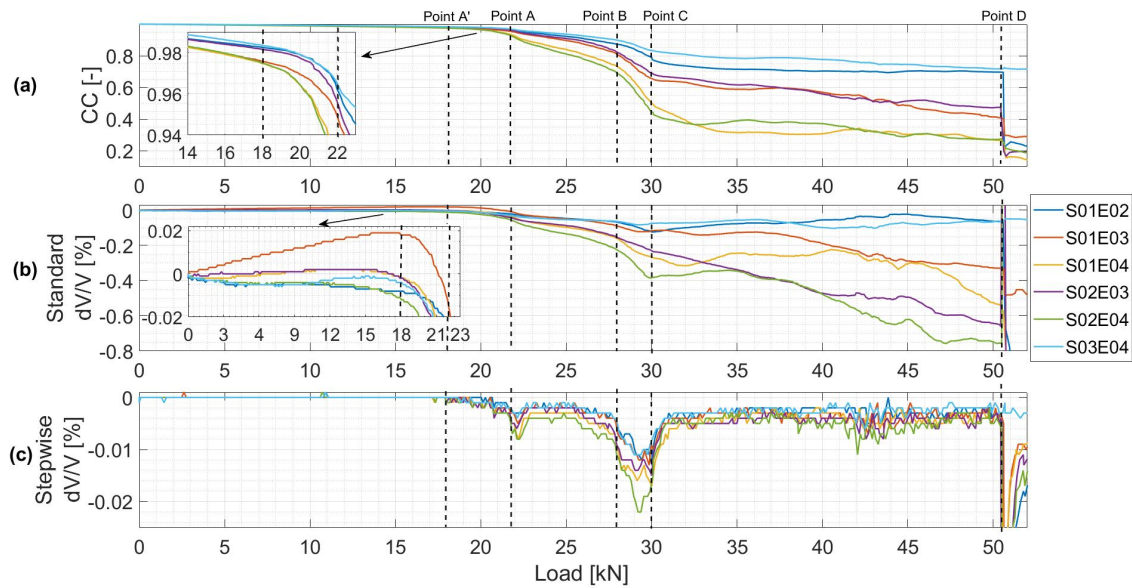
The CC and dV/V values, calculated by standard and stepwise CWI for all different combinations of sensors $S_{xx}E_{yy}$ (transmitter xx and receiver yy), are plotted in Figure 9. A reference signal was chosen for standard CWI calculations before any load was applied. The CC values for all different combinations decrease as the load increases continuously during the test (Figure 9a). CC and deflection plots took a similar trend as they are related to the stiffness of the reinforced concrete beam. As micro cracks propagate over the height of the beam, the similarity between the ultrasonic signals reduces and is accompanied by a rapid decrease in CC values. Similarly, standard dV/V values decrease during the test depending on stress changes and positions of the sensors (Figure 9b). During the linear elastic state, these values vary between 0.02% and -0.01% for S01E03 and S02E04 combinations where the two sensors were positioned, respectively, in the upper and bottom part of the beam. While dV/V decreases for combination S02E04, S01E03 dV/V increases linearly with the increase in compression stresses in the upper part of the beam. Indeed, the stress–velocity variation coefficient changes between different combinations depending on the location and the distance between the two transducers [34]. Local velocity changes compared with the previous signal are observed clearly from stepwise dV/V (Figure 9c). The changes in stepwise dV/V plots help distinguishing four main remarkable load levels similar to those observed in the deflection plots. CWI results and their relation to damage propagation will be discussed and compared with other sensors in Section 5.1.3.

Figure 9. (a) CC plots for each $S_{xx}E_{yy}$ combination. (b) dV/V plots for each $S_{xx}E_{yy}$ combination. (c) Stepwise dV/V plots for each $S_{xx}E_{yy}$ combination.

While Figure 9 presents the results of CC and dV/V calculated from US sensors measurements, Figure 11 shows the DFO strain measurements at the location of cracks 1 and 2 compared to displacements (crack openings) and strains measured respectively by LVDT (1, 2, 3) and SG (1, 2). Cracks 1 and 2 refer to the first crack detected at the center of the beam and the second one 20 cm away from the center (monitored by LVDT 3).

The formation of crack 1 is first detected by US and DFO sensors. When the load exceeded 18 kN, a first variation in velocity for S02E04 combination is observed from stepwise dV/V plot (Figure 9c). This decrease in dV/V followed shortly by other combinations is due to the propagation of the micro crack. The standard dV/V plots show that this fall in dV/V value is the highest between the two closest transducers located on the bottom part of the beam (combination S02E04). On the other hand, the smallest variations are observed for combinations S01E02 and S03E04 as the direct waves between these transducers do not bridge through the crack. CC plots follow a similar trend as dV/V plots.
